**PG&E Point Buchon Ocean Bottom Seismometer (OBS)  
Project, System Removal Biological Survey Report  
(September 8, 2015)**

September 8, 2015  
Project No. 1102-0621

Subject: PG&E Point Buchon Ocean Bottom Seismometer (OBS) Project, System Removal  
Biological Survey Report

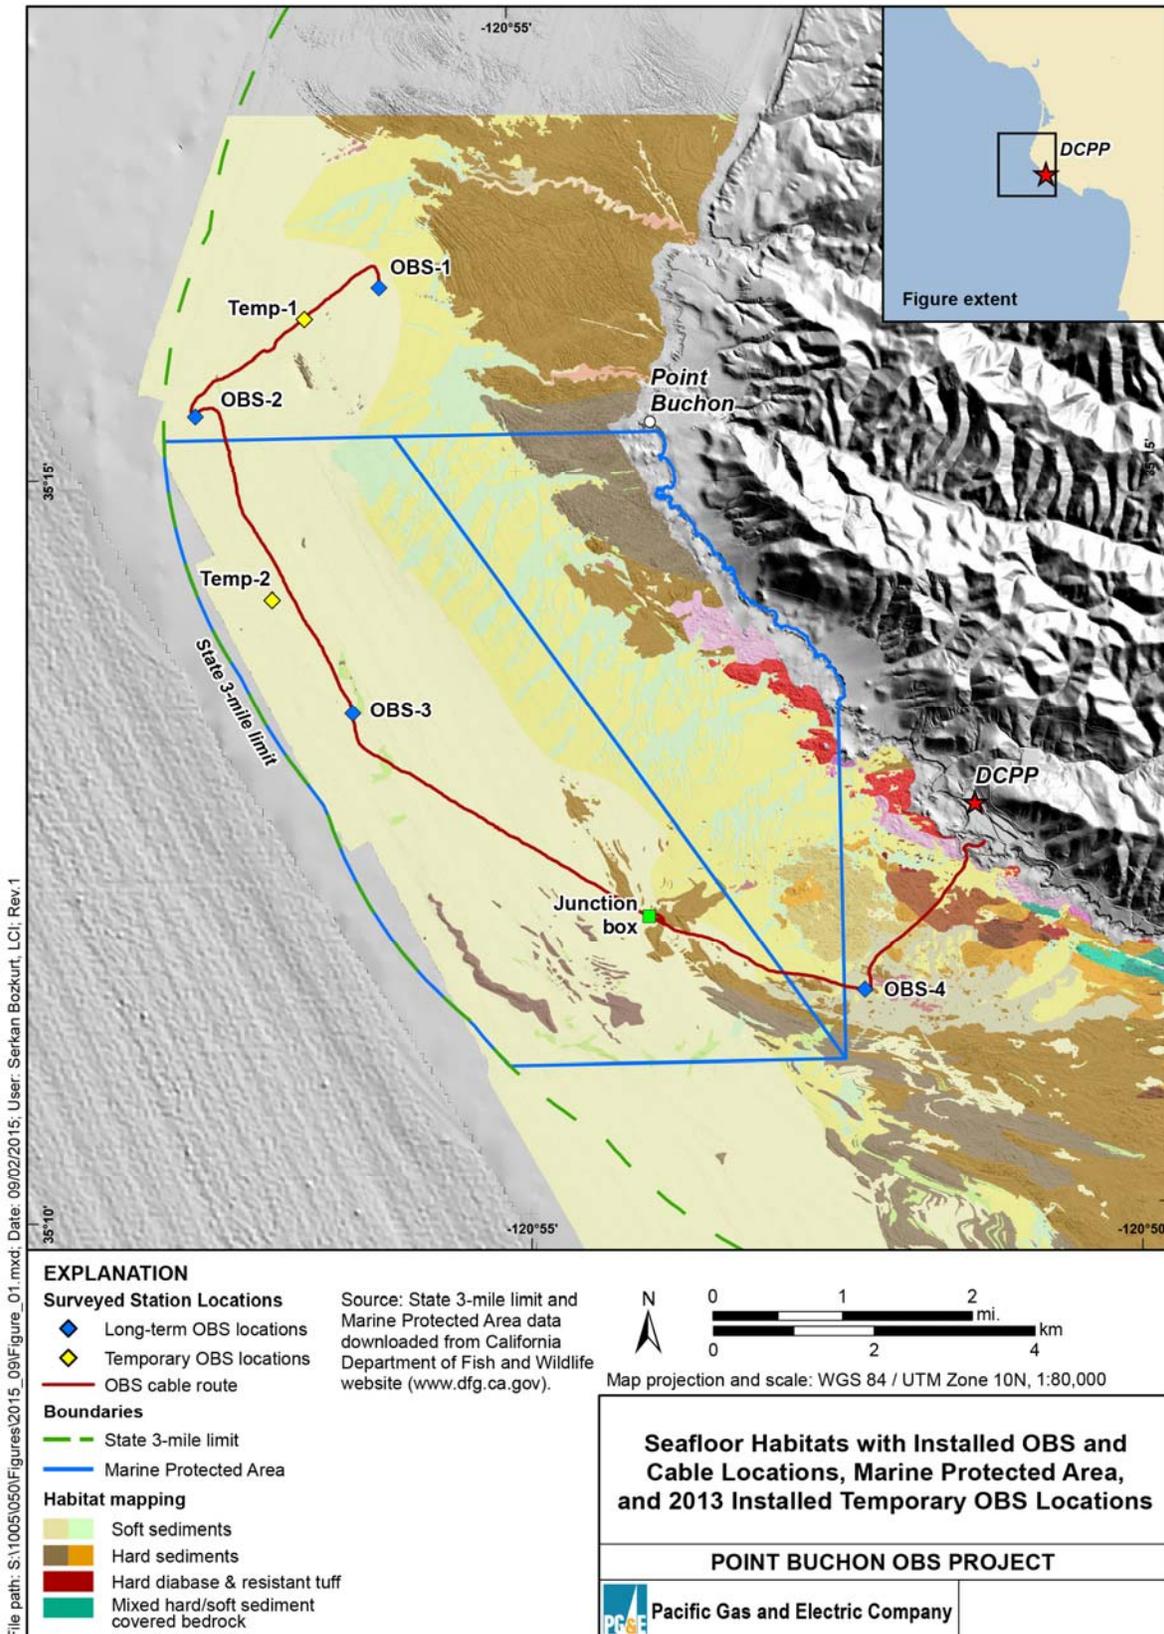
Figure 1. Region and Site Seafloor Habitats with Installed OBS and Cable Locations

The deeper water segment (greater than 76 ft) was completed by a remotely operated vehicle (ROV) survey over a three-day period (May 27 through 29, 2015) and utilized a Phantom 2+2 ROV, owned and operated by Aqueos Corporation under subcontract to Padre. The ROV was equipped with a scanning sonar and video cameras. The M/V *Surveyor*, a 100 ft [31m]-long, steel-hulled vessel owned and operated by Maritime Logistics, was the ROV support vessel. ROV and vessel positioning was provided by Fugro Pelagos, Inc. The ROV survey was initiated at the approximate termination point of the Tenera dive survey and progressed to the west and north (Attachment A, Figure 1).
